SwissCube Status

02 May 2010

Status of SwissCube in Space

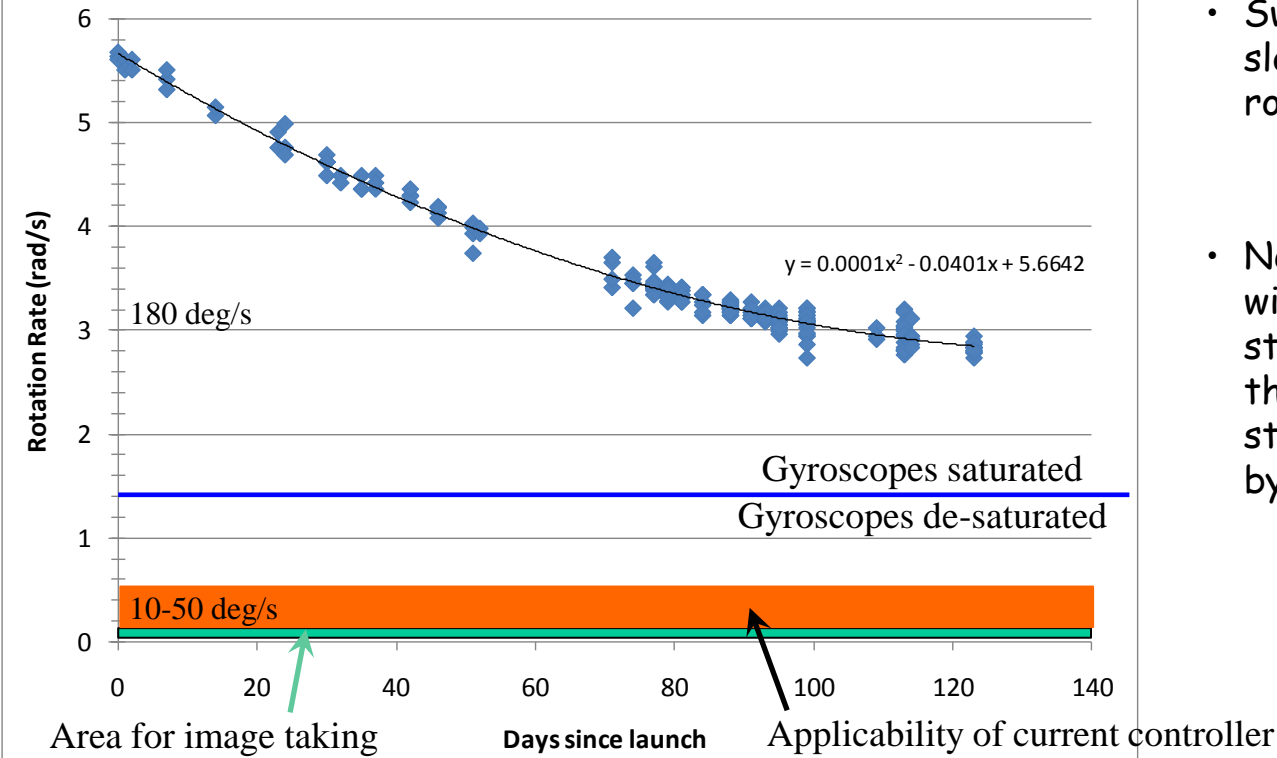
Rotation Rates

SwissCube rotation rates from Oct. 23 to Feb. 26, 2010

- SwissCube's rotation has naturally slowed down to almost half its initial rotation rates
 - But slow down rate is decreasing
- New simulations done in cooperation with ISIS (NL) show there may be a strategy for actively slowing down the satellite (Bdot controller may be stable even at high rotation rates), by uploading new parameter values
 - Investigating validity and verification of simulations before implementation

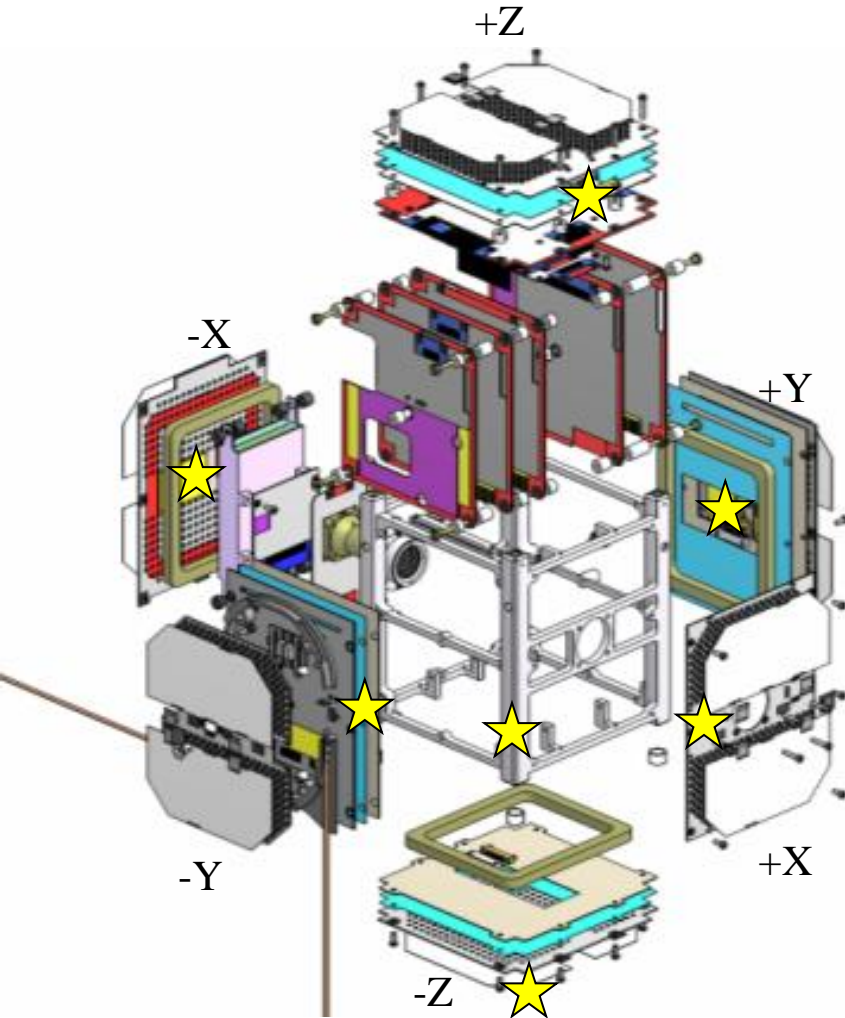
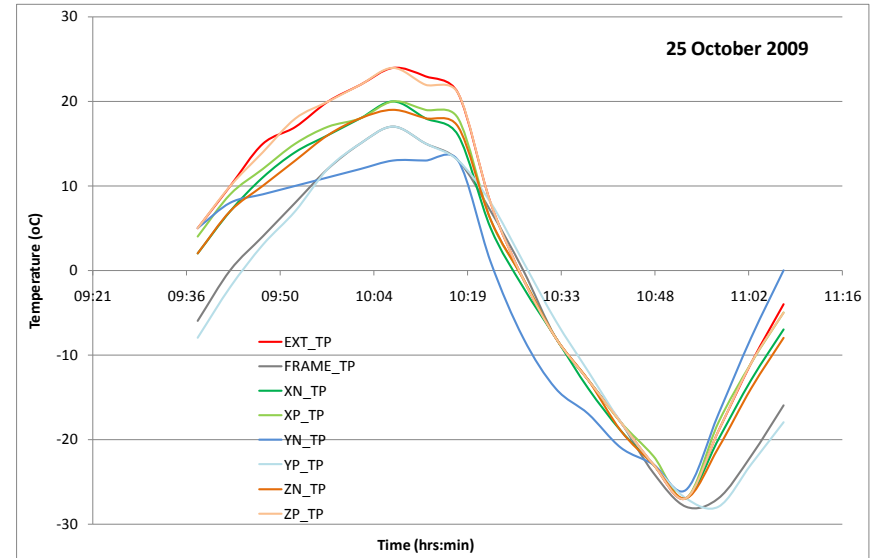
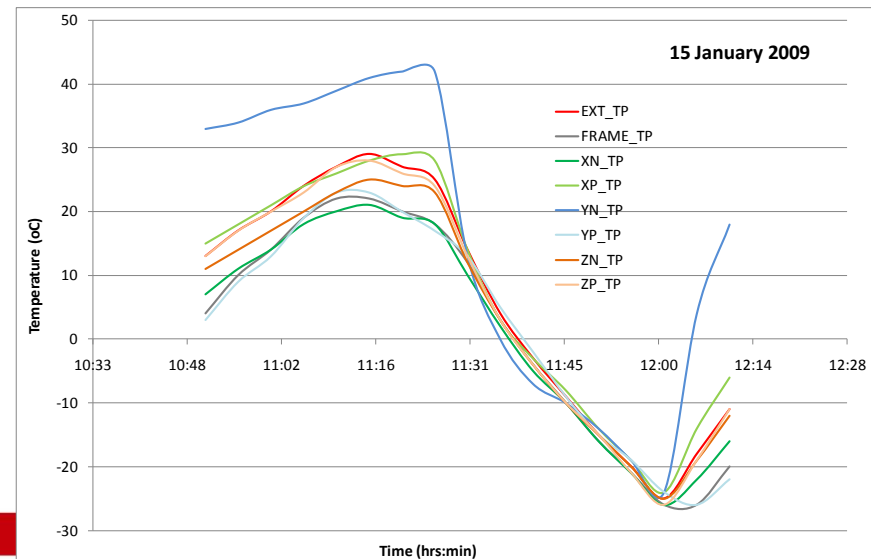
Satellite external temperatures

... within design margins and tests (-50/+70 °C)

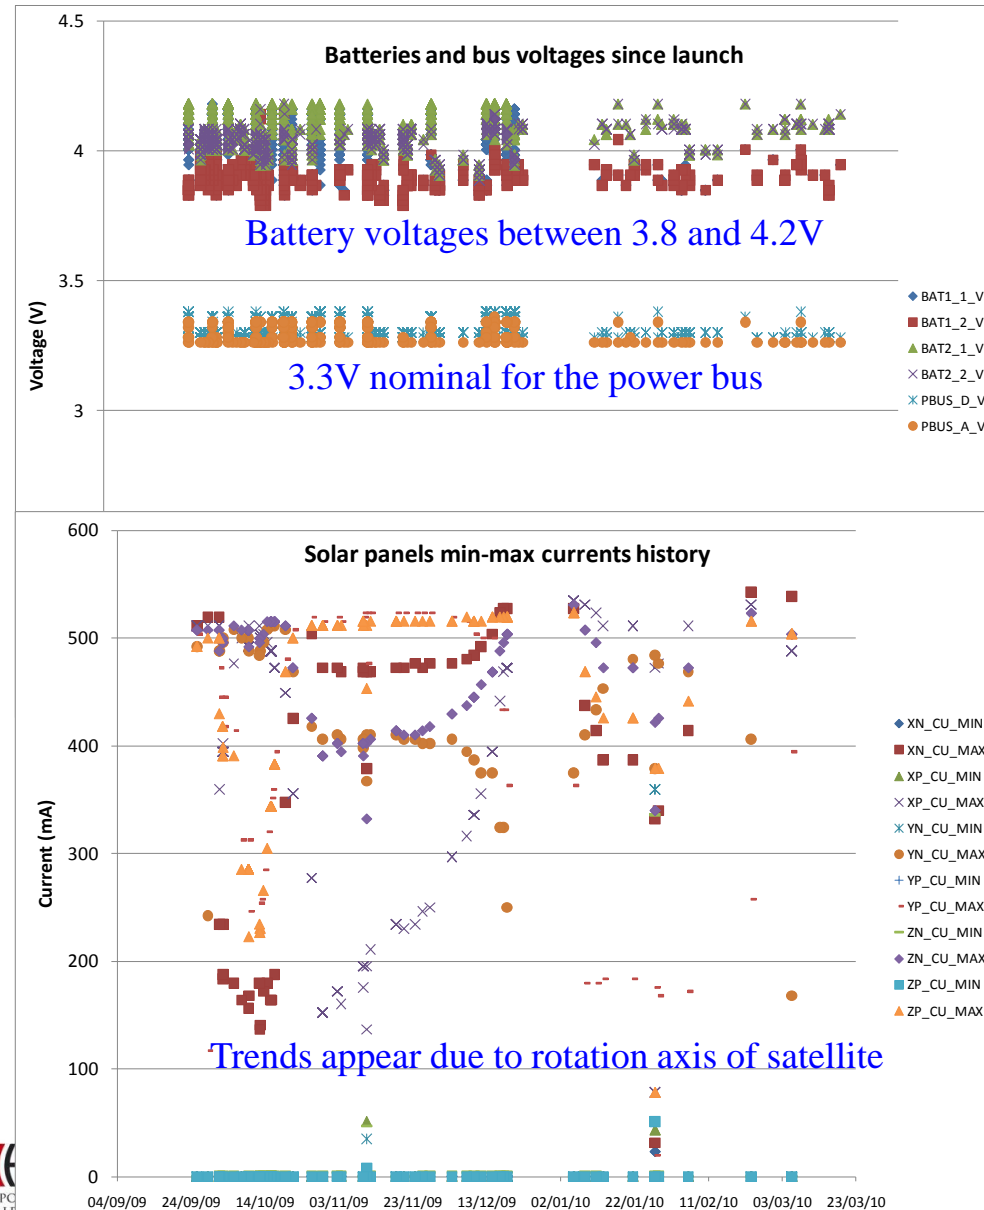
On-board Power System

- Power system still working perfectly
- Batteries and power bus voltages are also within performance expectations
- Solar panels currents indicate that all solar panels are functional and within performance expectations

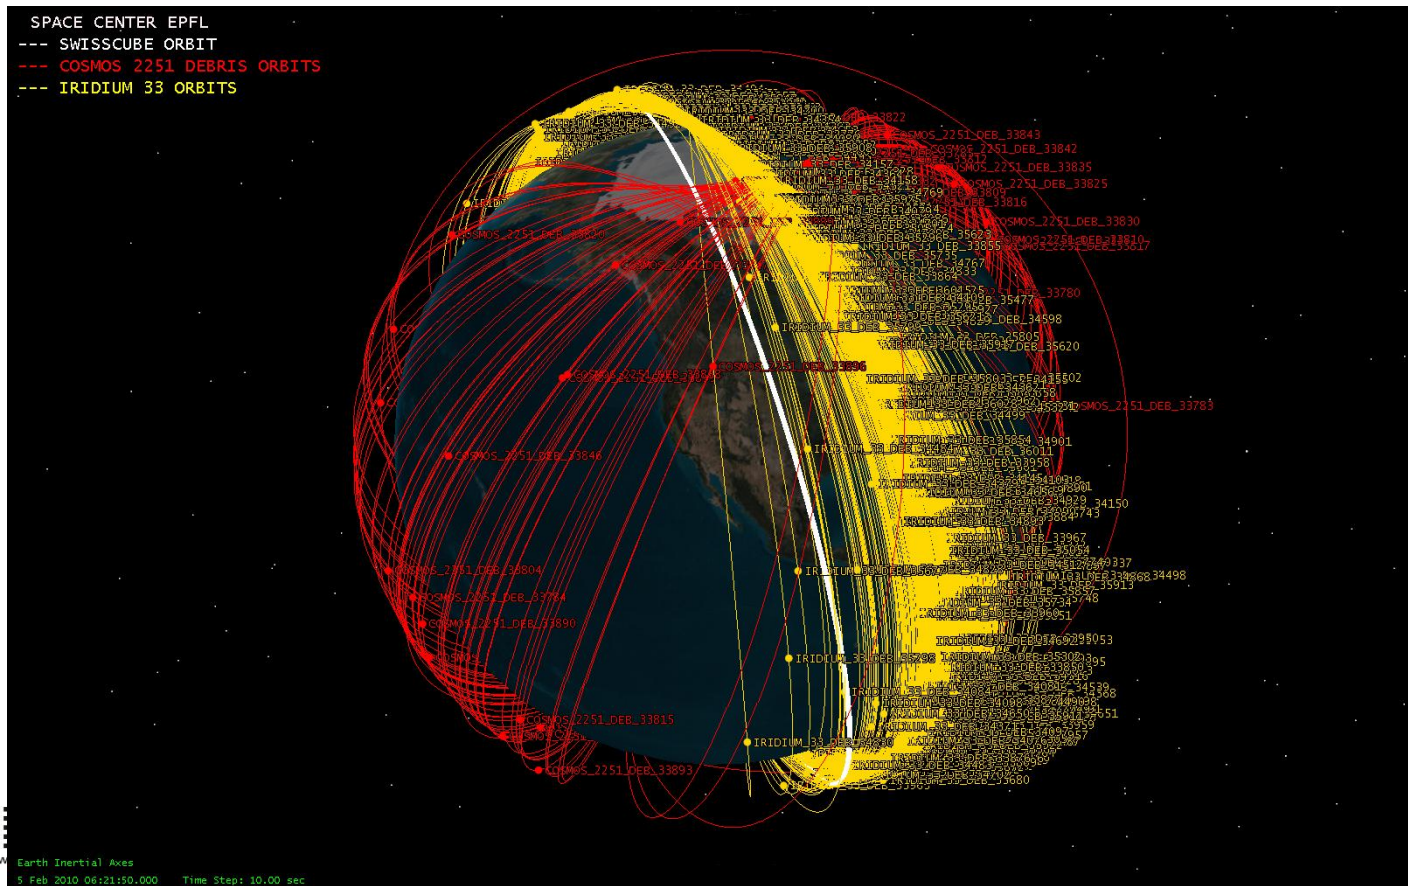
Encounter with orbital debris

- Close encounter with orbital debris on Friday Feb. 5, 6h20 predicted by the United States Joint Space Operations Center (JSpOC)
- Debris SCC #34891 resulting from the IRIDIUM/COSMOS collision last year
- Scenario very likely to happen again...
